COPELAND  
BUILDING  
ENVELOPE  
CONSULTING

# CASE STUDY: CHIMNEY CAP FLASHING

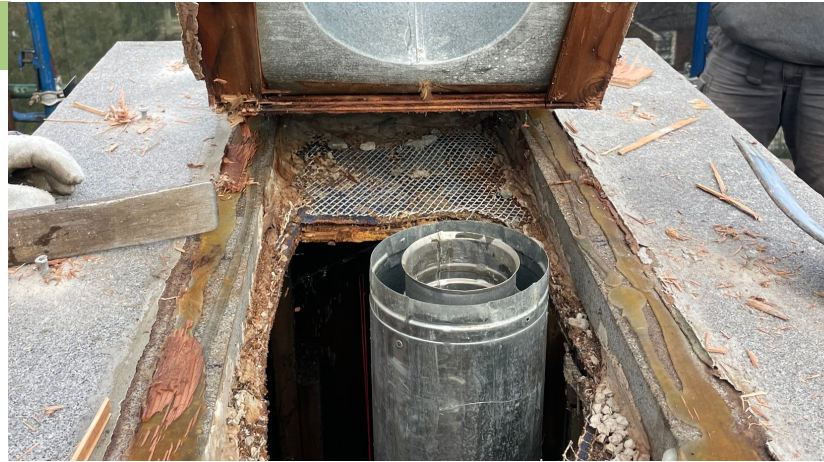
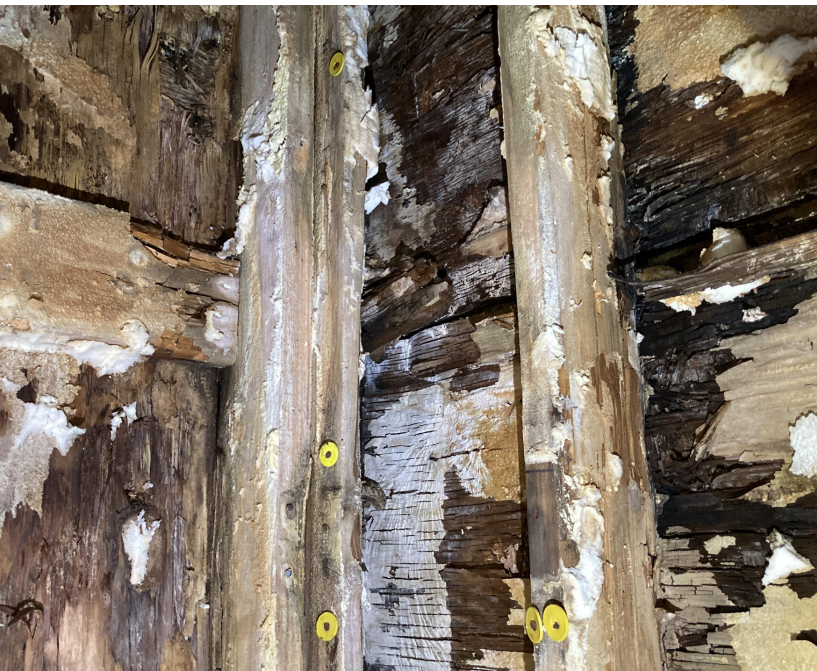
A single-family residence chimney's lack of proper metal or membrane cap flashing allowed water intrusion into the chimney's wood frame structure.

This residence experienced water ingress and damages to interior finishes. Further investigation identified significant deterioration to the chimney's wood frame structure.

- demolition and rebuild of the entire masonry clad chimney, including full height scaffolding
- installation of a new fully-soldered and sloped-to-drain copper chimney cap with proper flashing transitions between the chimney cap, exterior walls, and roof systems
