**COPELAND
BUILDING
ENVELOPE
CONSULTING**

CASE STUDY: KICK OUT FLASHING

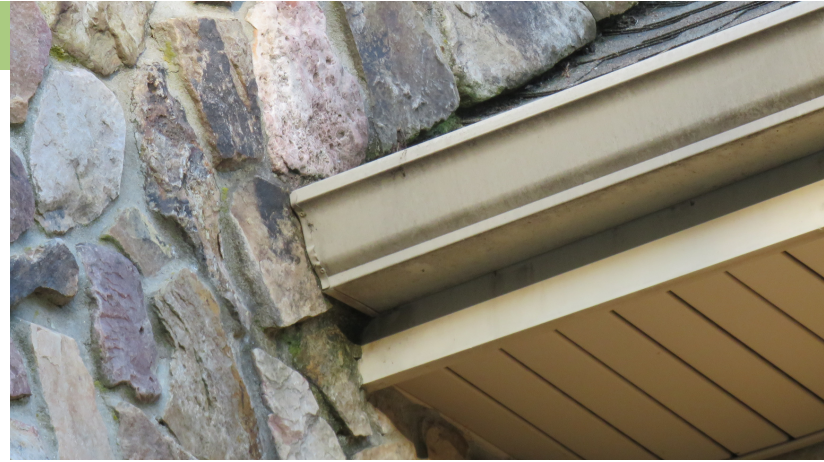
A condominium community building's lack of "kick-out" flashing at roof eave-to-wall transitions allowed for bulk water ingress behind an exterior wall's stone veneer cladding.

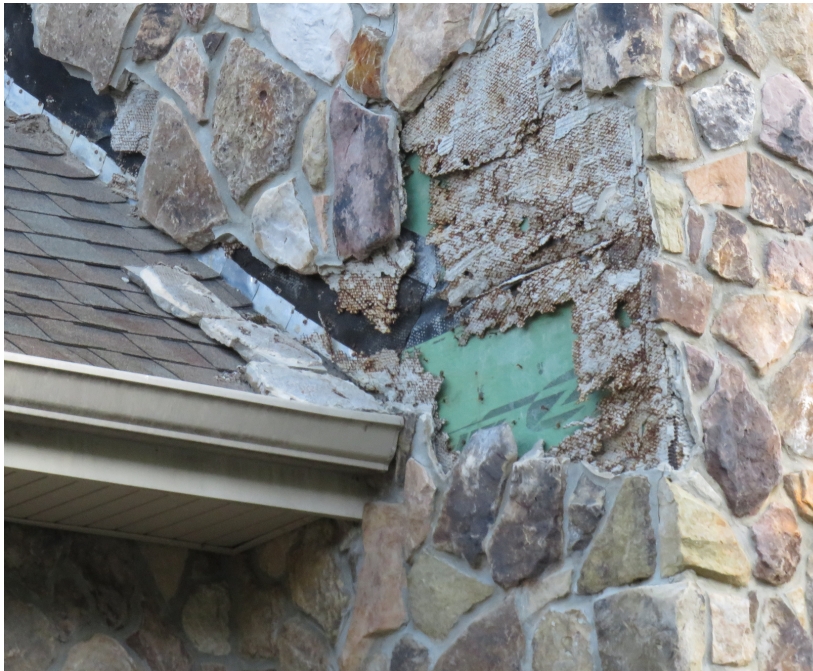
This property experienced failed stone veneer cladding and significant metal lath corrosion at roof eave-to-wall transitions due to a lack of kick-out flashing coupled with a poorly drained stone veneer cladding system which resulted in a safety risk for pedestrians below due to falling cladding stones.

Required Repairs:

- remove and replace the exterior cladding system
- install new "kick-out" flashing at the roof eave to wall transition
